Manhole Inspection Summary

Manhole # S41C__033MH

Location Address: **201 sprig ct**

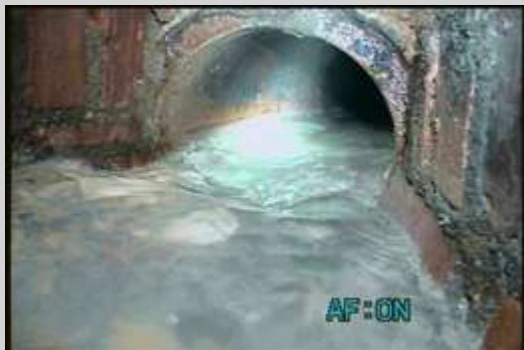
12 O'Clock Outflow

8 in. Circular Gravity Sewer
Pipe Out @ 12 O'Clock

Pipe Material: **Clay** ☐ Pipe Lined

Invert Depth: **10.94** (ft.) Flow Characteristics: **Fast**

Infiltration: **None** Pipe Seal Cond: **Unknown**

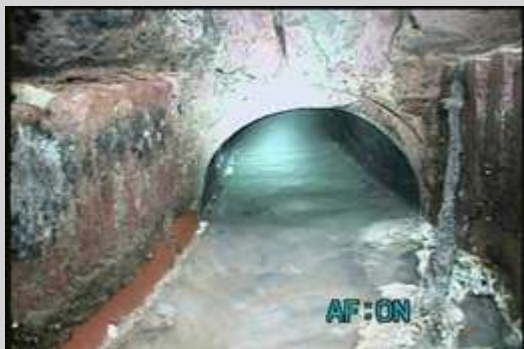
6 O'Clock Inflow

8 in. Circular Gravity Sewer
Pipe In @ 6 O'Clock

Pipe Material: **Clay** ☐ Pipe Lined

Infiltration: **None** Pipe Seal Cond: **Unknown**
